*(Paper No. 4223.)*

## “Slips and Subsidences on the Ceylon Government Railways.”

By AUSTIN GEORGE COOPER, M. Inst. C.E.

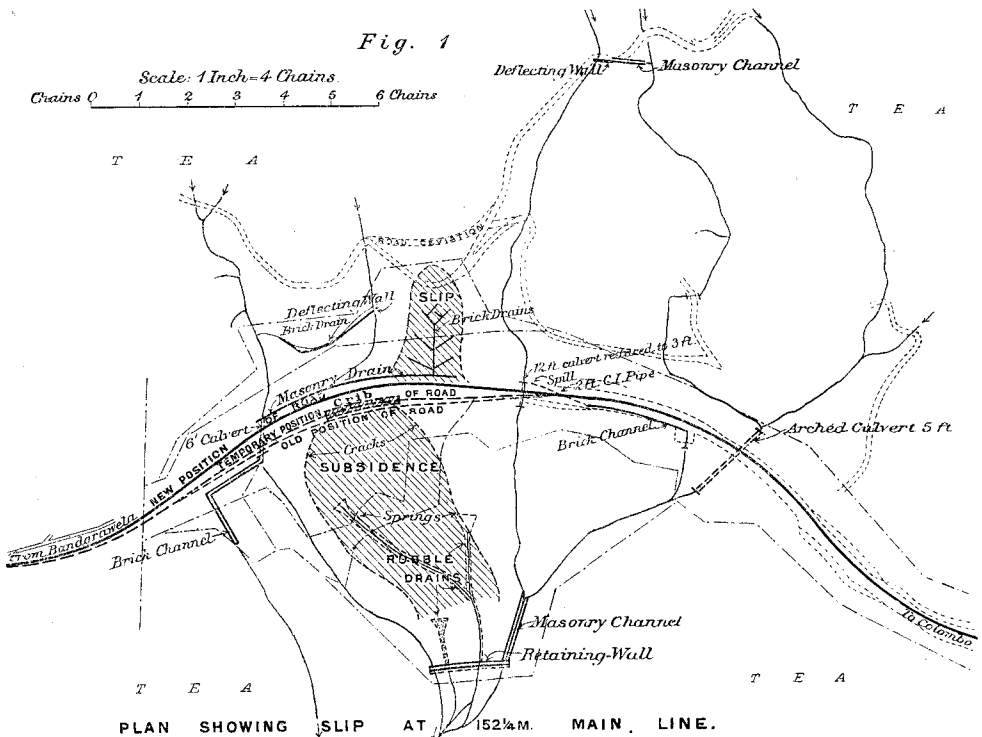
Fig. 1

*Slip at 152 Miles 20 Chains* (Fig. 1, Plate 3).—The line here descends along the side of a mountain spur reaching into the province of Uva, and at this point is at an elevation of about 5,000 feet above sea-level and on steep sidelong ground. The subsidence was caused by the land at the foot of the slope becoming waterlogged by the overflow from the streams. When the slip began the formation cracked and sank 10 feet for a length of 80 feet, the cracks extending out and down to the foot of the slope 250 feet below the line, the whole of the area enclosed subsiding and breaking up. The temporary measures consisted of sluing the track as far as possible towards the cutting, which is about 70 feet deep, excavating down to a solid benching and building a sleeper crib to carry the track.

The permanent work consists of stream diversions above and at formation-level, to take the water permanently away from the subsidence, widening the cutting and deviating the track on to solid formation sufficiently far from the subsidence to ensure safety in the future, building a concrete retaining-wall at the foot of the slope below the railway, lining portions of the stream-courses above the wall with masonry, and draining the slope above with deep rubble drains, these discharging through the wall, and the streams over it. The retaining-wall is slightly curved in plan, and is reinforced with old angle check-rails. A further slip occurred while the work was in progress, the cutting above the track slipping in for a length of 100 feet, due to springs issuing from its face, and this was removed, while the slope was trimmed back, and the springs were led down brick drains to the masonry side-drain. The excavation at this place is in "cabook" clay, which stands safely at an angle of  $60^\circ$  to the horizontal, but is liable to slip at this angle when water is present.

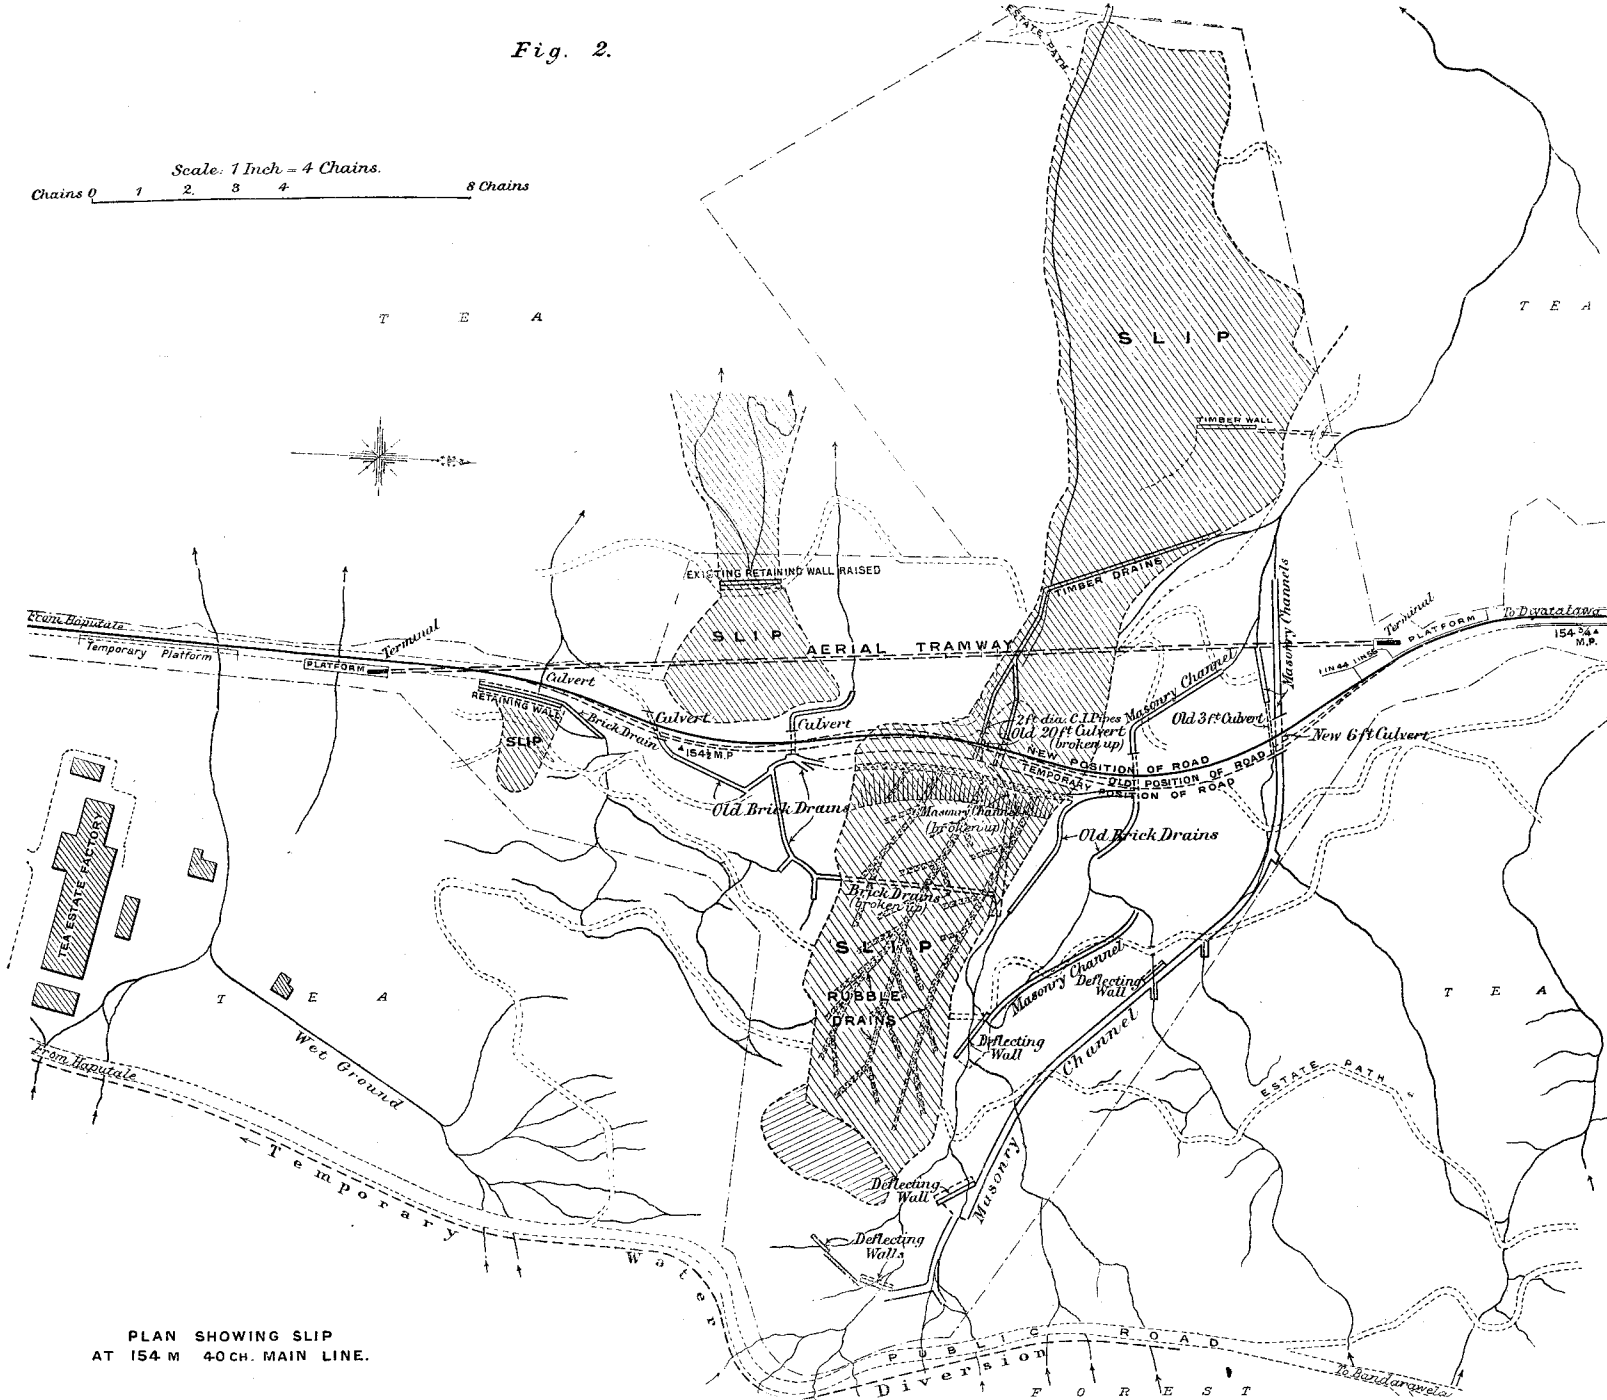
*Slip at 154 Miles 40 Chains* (Fig. 2, Plate 3).—The line at this place runs through a tea estate along a hillside, the ground being intersected by steep stream courses which, during dry weather, carry no water, but in the rainy season are swollen into small torrents. The area covered by the slip is about 15 acres, and the surface to a considerable depth is composed of sandy clay, thickly set with boulders. Movements in this area have taken place since, and probably before, the construction of the railway. The land had become waterlogged, and in a semi-fluid condition was moving piecemeal down the slope, different parts moving in different years and seasons.

The lower strata appear to have become more mobile than the surface strata, and the consequence of this has caused subsidences of the surface, as the lower strata flowed from under it, portions of the harder surface and boulders lying about irregularly. About 1902, certain protective works, comprising brick drains, a masonry channel and a retaining-wall, were built. Between 1902 and 1912 the work was carefully maintained, but the settlement increased slowly until December 1912, when it began to assume a serious character, causing delays to traffic while temporary repairs were carried out. In the following month, as a result of heavy continuous rain, the damage was extensive. A 20-foot culvert was carried away, portions of the protective work built previously were broken up, and the line was blocked across the slip with boulders and clay 25 feet in depth, the whole of the ground becoming a spongy mass, moving down the hillside at a rate which, for a time, was about 2 feet 6 inches daily. For a short period passenger traffic was maintained by transferring passengers and mails round the slip, but, owing to numerous other slips and washaways occurring shortly afterwards on this section, traffic was completely stopped for a few days, and was not fully restored until about 3 weeks later.

The temporary measures for restoration of the traffic consisted of water diversions above the slip in open earth cuttings, with rough masonry walls and timber sluices at the streams, in order to provide relief in case of further heavy rains, cutting through the slip and placing the line on a temporary deviation, keeping the slip cut back on the high side as far as possible from the line, and the installation of an aerial tramway, 1,408 feet long, of a tested working capacity of 10 tons per hour, to carry goods in case of the line again becoming blocked. It was not, however, necessary to use this tramway. Since the permanent work has been completed no large movement of the slip has occurred.

The permanent works comprise water-diversions, cutting back and draining the slip, deviating the track, building retaining-walls and other minor work, as shown in Fig. 2. The main water-diversion consists of deflecting-walls across the stream-courses, taken down to a solid foundation and connected by a masonry channel, from a point above the top of the slip, down to a new 6-foot arched culvert built under the track, with a masonry outlet stepped down to the natural stream-course well clear of the slip. A smaller water-diversion was also built consisting of a deflecting-wall and masonry channel to catch water collected on the area below the main diversion and above the slip. This was taken down to the existing 3-foot culvert, the outlet of which was extended to convey

the water to a point near the outlet of the 6-foot culvert. The deflecting-walls were built of squared masonry in cement mortar with Portland-cement concrete footings. The channels were of squared masonry in cement mortar, the side walls being fine-jointed, but the invert with 2-inch joints filled with fine concrete. For the greater part of the length of the channel the excavation was in hard clay and no concrete was required under the masonry invert, but where the foundations were not so good this was provided. The slip was cut back clear of the track on the high side to a width of 50 feet with a slope of 2 horizontal to 1 vertical, and deep rubble drains were laid to ensure good drainage, the water from these drains being clear of the slip.

The permanent deviation was made to remove the track as far as possible from the toe of the portion of the slip above the line, and to flatten the curves to meet any sharpening which might occur if any further movement took place. This deviation entailed lengthening some of the existing culverts, and widening the formation in places. A retaining-wall was built, and an existing retaining-wall raised at the bottom of two smaller detached portions of the slip. These walls are of Portland cement concrete, and are of the usual section with battered face. The area of the slip has been planted with grass and acacia trees to bind the surface, and to throw off the water.

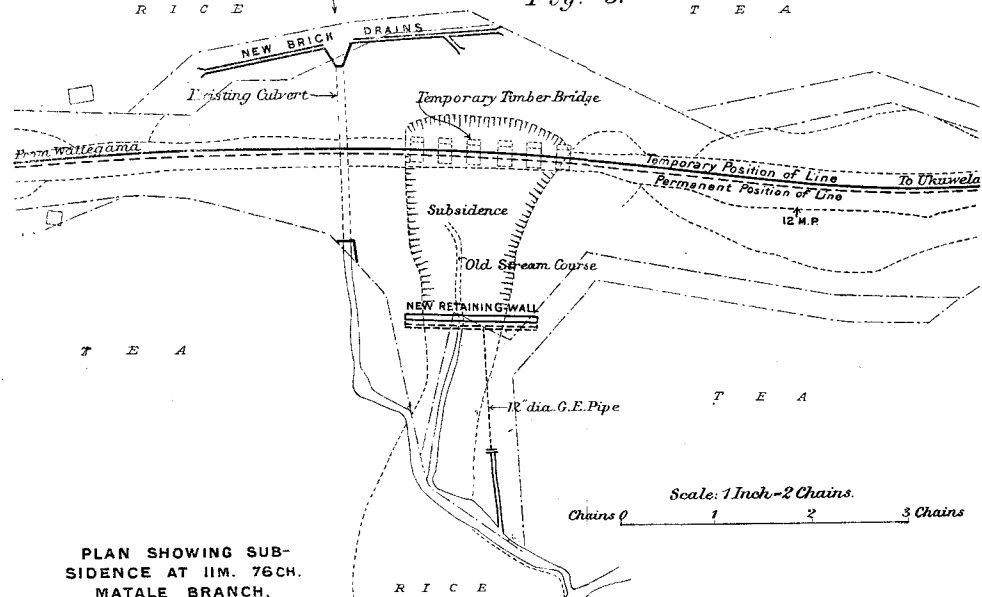
Fig. 3.

*Subsidence at 11 Miles 76 Chains (Fig. 3, Plate 3).*—Here the line crosses rice-fields on a high embankment, which became waterlogged and partially subsided. A temporary bridge of sleeper-cribs and baulk timber was built to carry the road temporarily, and the following permanent work was executed. Brick drains were constructed to replace open earth drains above the embankment, to take the water to the existing culvert. A retaining-wall was built at the toe of the embankment on the low side, with drainage through the wall down to the stream-course below. The excavation for the wall was in trench, and it was built of Portland cement concrete reinforced with old angle check-rails. When refilling the embankment, the sleeper-cribs were removed one at a time, working from one end of the bridge by bridging over each crib in turn with suitable shallow girders, which were built locally, the ends of the girders resting on the next crib forward, and on smaller cribs built on the new bank, which had been well rammed. The filling was obtained from side-cut at each end of the embankment, and was run out by skip-roads. The embankment, after being filled, was turfed. Similar subsidences occurred at 12 miles, 26 chains; 13 miles, 22 chains; and 14 miles, 3 chains on this branch, and were dealt with in the same manner.
